## DIANNE COPPER MINE

### Recommencement Project Soil Assessment

Report prepared for:  
Mineral Projects Pty Ltd

Dianne Copper Mine – Recommencement project soil assessment (amended report)

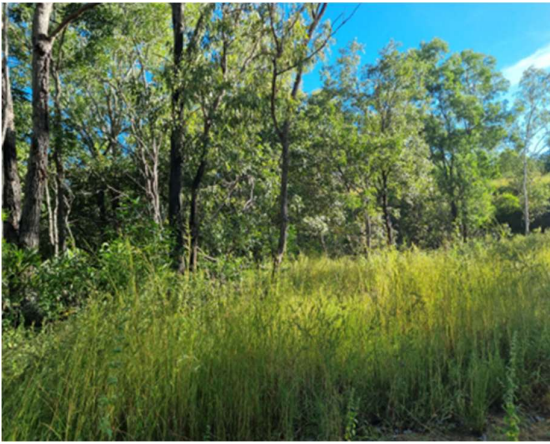
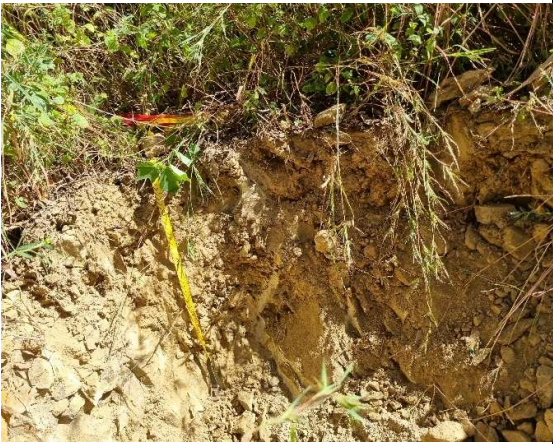
| SS3 site setting | SS3 soil pit |

| | B3 | 40 | 80 | Reddish-brown (2.5YR 4/4) | No mottles or other colour patterns mottles | Medium clay | Strong 2–5 mm polyhedral structure | Abundant (50–90%) angular metamorphic rock (unidentified) small pebbles (2–6 mm); few (2–10%) angular metamorphic rock (unidentified) medium pebbles (6–20 mm) |

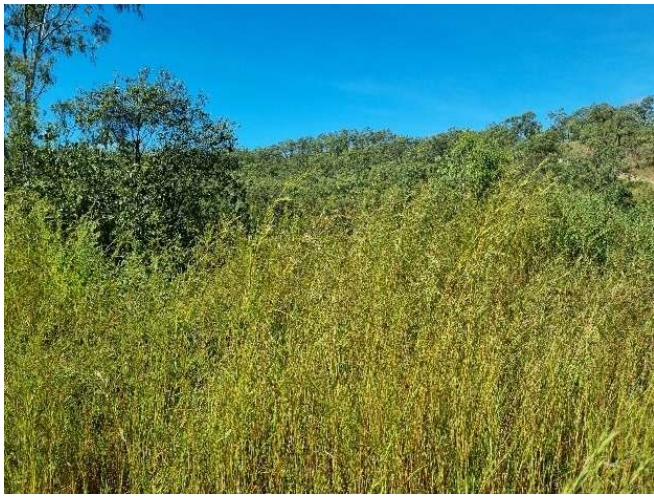
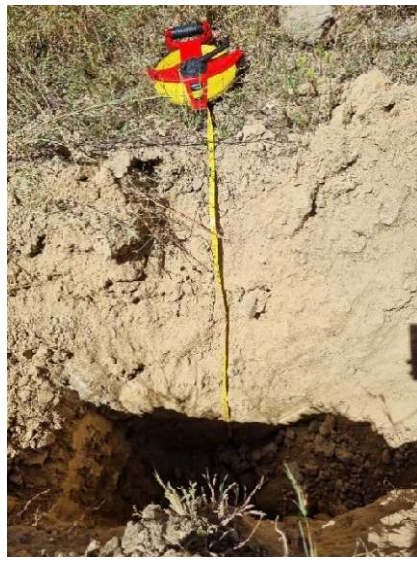
| SS4 site setting | SS4 soil pit |

| | B3 | 45 | 80 | Reddish-brown (2.5YR 4/4) | No mottles or other colour patterns | Medium clay | Strong 2–5 mm polyhedral structure | abundant (50–90%) angular metamorphic rock (unidentified) small pebbles (2–6 mm); few (2–10%) angular metamorphic rock (unidentified) medium pebbles (6–20 mm) |

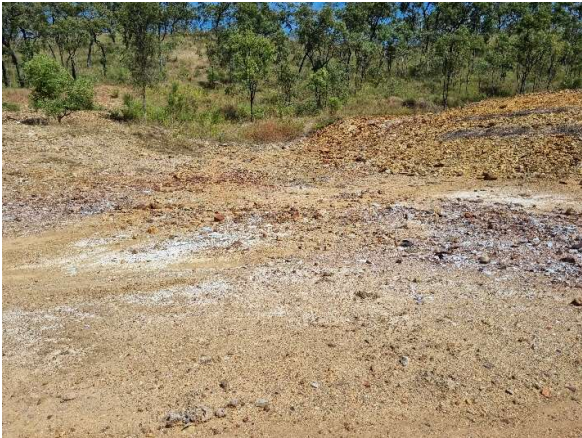
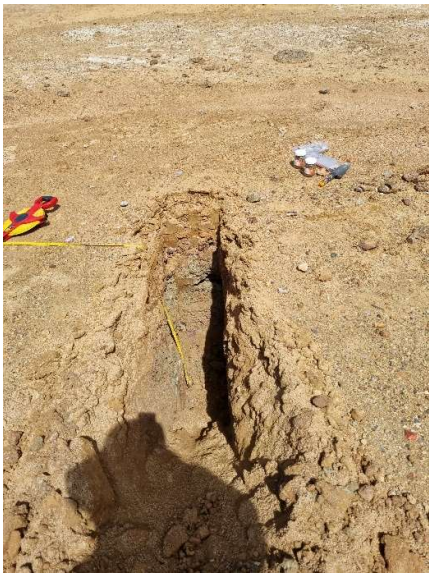
| SS5 site setting | SS5 soil pit |

Most of the soil profiles observed as part of this investigation were natural profiles, with local disturbances confined to grazing and adjacent tracks. Site SS5, however, is highly disturbed by anthropogenic activity (i.e. historical mine works) and entirely altered. Thus SS5 is classed as an anthroposol.

| | B3 | 35 | 100 | Brown (7.5YR<br>5/3) | No mottles or<br>other colour<br>patterns<br>mottles | Medium<br>clay | Strong 2–5<br>mm<br>polyhedral<br>structure | abundant (50–<br>90%)<br>angular<br>metamorphic<br>rock<br>(unidentified)<br>small<br>pebbles (2–6<br>mm);<br>few (2–10%)<br>angular<br>metamorphic<br>rock<br>(unidentified)<br>medium pebbles<br>(6–<br>20 mm) |

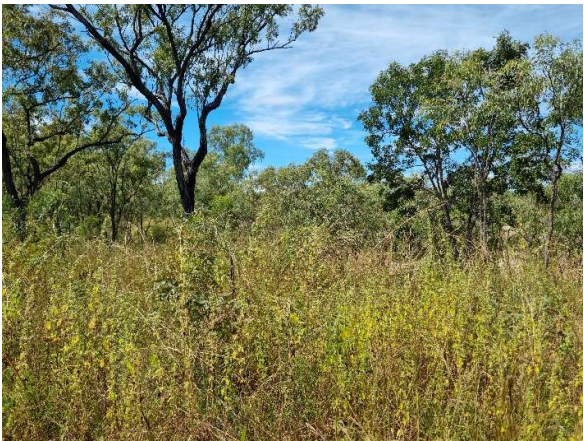
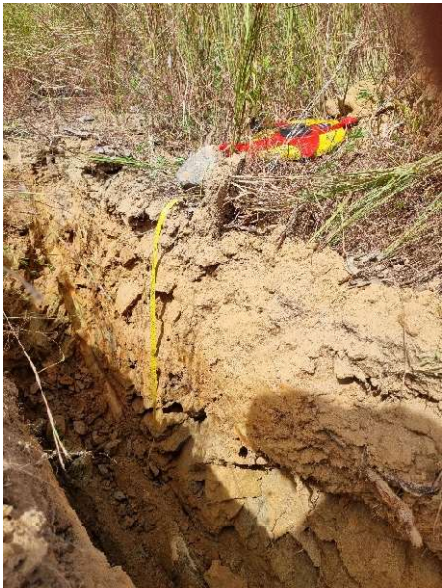
| SS6 Site setting | SS6 soil pit |

| | B3 | 45 | 80 | Reddish-brown (2.5YR 4/4) | No mottles or other colour patterns mottles | Medium clay | Strong 2–5 mm polyhedral structure | abundant (50–90%) angular metamorphic rock (unidentified) small pebbles (2–6 mm); few (2–10%) angular metamorphic rock (unidentified) medium pebbles (6–20 mm) |

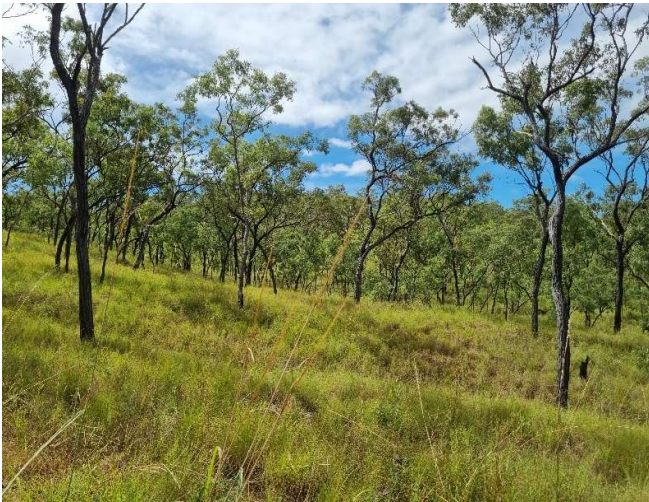
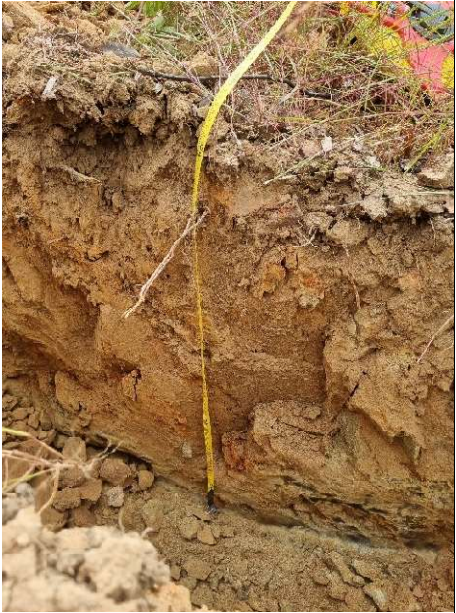
| SS2 site setting | SS2 soil pit |

| | B3 | 60 | 100 | Reddish-brown (2.5YR 4/4) | No mottles or other colour patterns mottles | Medium clay | Massive structure | Many (20–50%) angular metamorphic rock (unidentified) small pebbles (2–6 mm) |

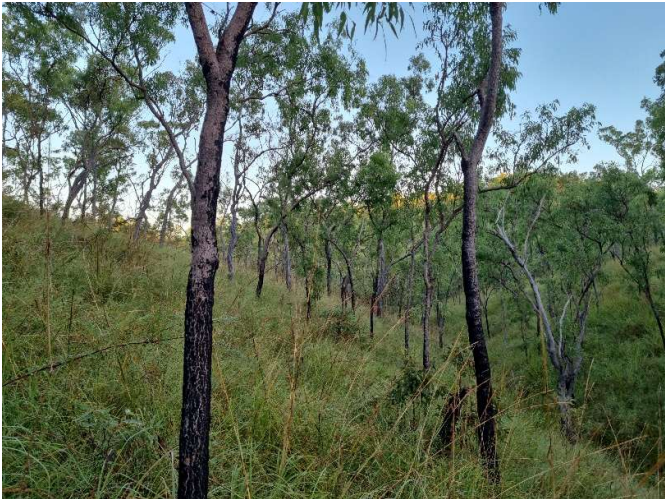
| SS10 site setting | | No soil pit due to sampling method |

| SS1<br>0-<br>Sub | B2 | 12 | 55 | Red<br>(2.5YR<br>5/6) | No mottles or other colour patterns mottles | Medium clay | Massive structure | Many (20–50%) angular metamorphic rock (unidentified) small pebbles (2–6 mm) |

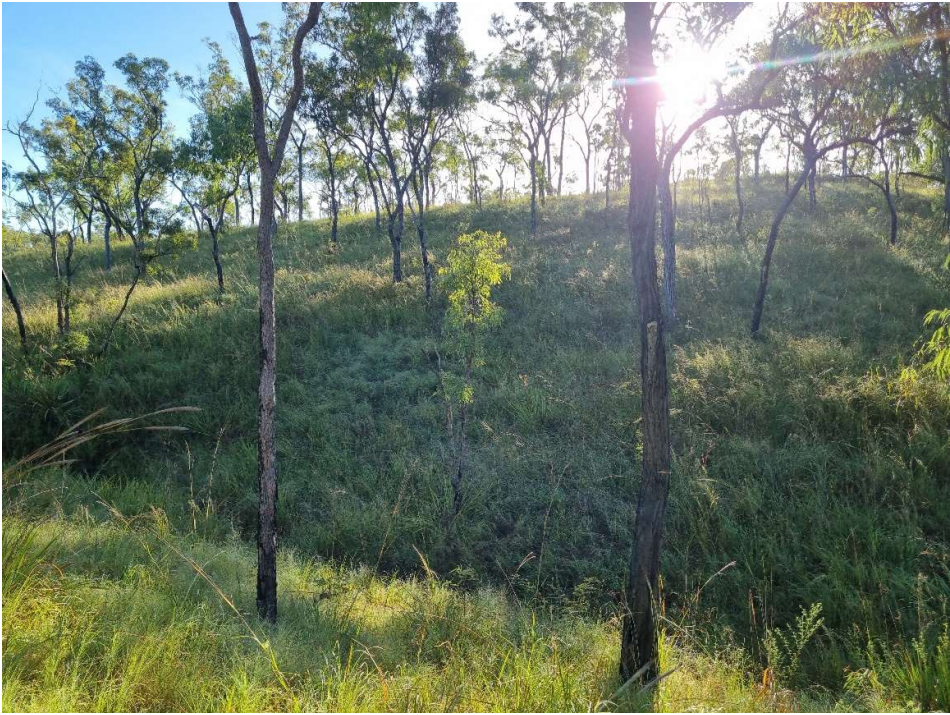
| SS09 site setting | | No soil pit due to sampling method |

| SS09Sub | B2 | 15 | 60 | Reddish-brown (5YR 5/3) | No mottles or other colour patterns mottles | Medium clay | Massive structure | Many (20–50%) angular metamorphic rock (unidentified) small pebbles (2–6 mm) |

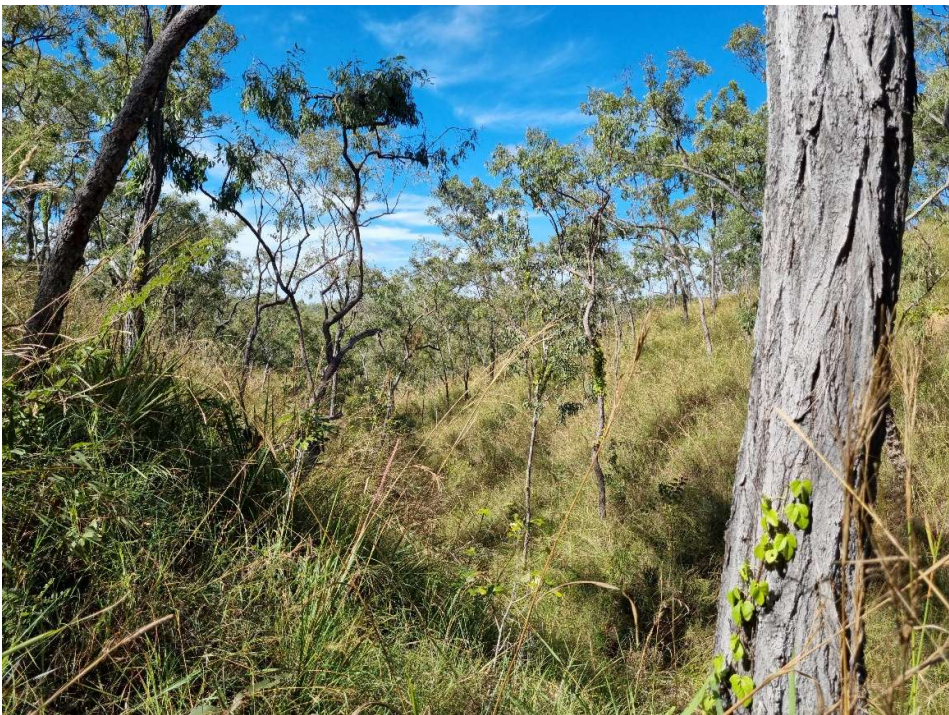
| SS07 site setting | | No soil pit due to sampling method |

| SS0<br>9Sub | B2 | 20 | 65 | Brown (7.5YR 5/3) | No mottles or other colour patterns mottles | Medium clay | Massive structure | Many (20–50%) Angular metamorphic rock (unidentified) small pebbles (2–6 mm) |

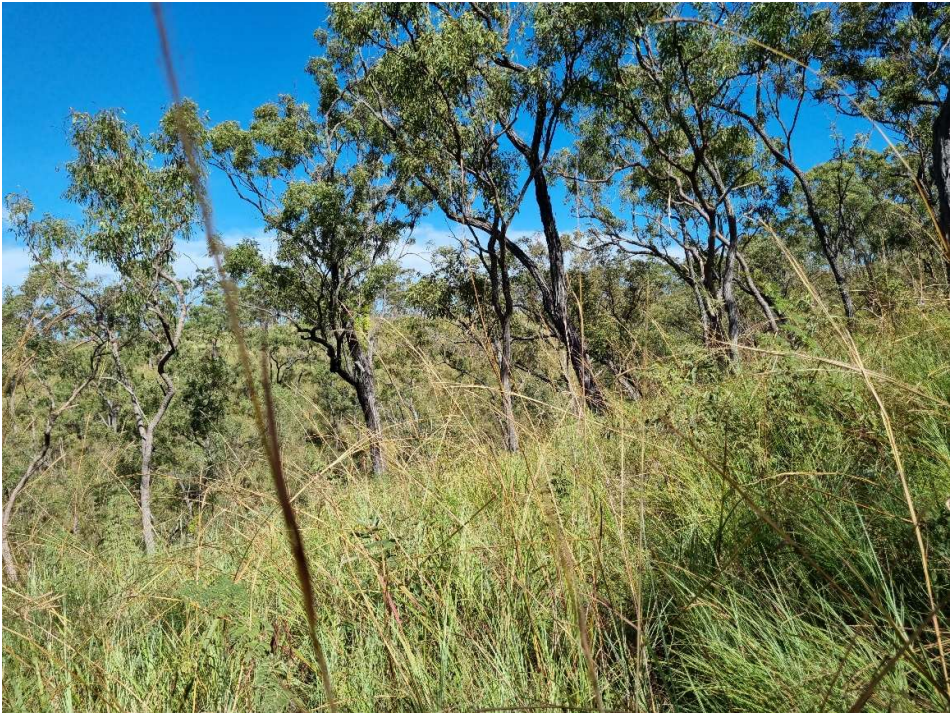
| SS08 site setting | | No soil pit due to<br>sampling method |

| SS0<br>8Sub | B2 | 18 | 60 | Pinkish-<br>grey<br>(7.5YR<br>6/2) | No mottles or<br>other colour<br>patterns<br>mottles | Light<br>clay | Massive<br>structure | Many (20–50%)<br>angular<br>metamorphic<br>rock<br>(unidentified)<br>small pebbles<br>(2–6 mm) |

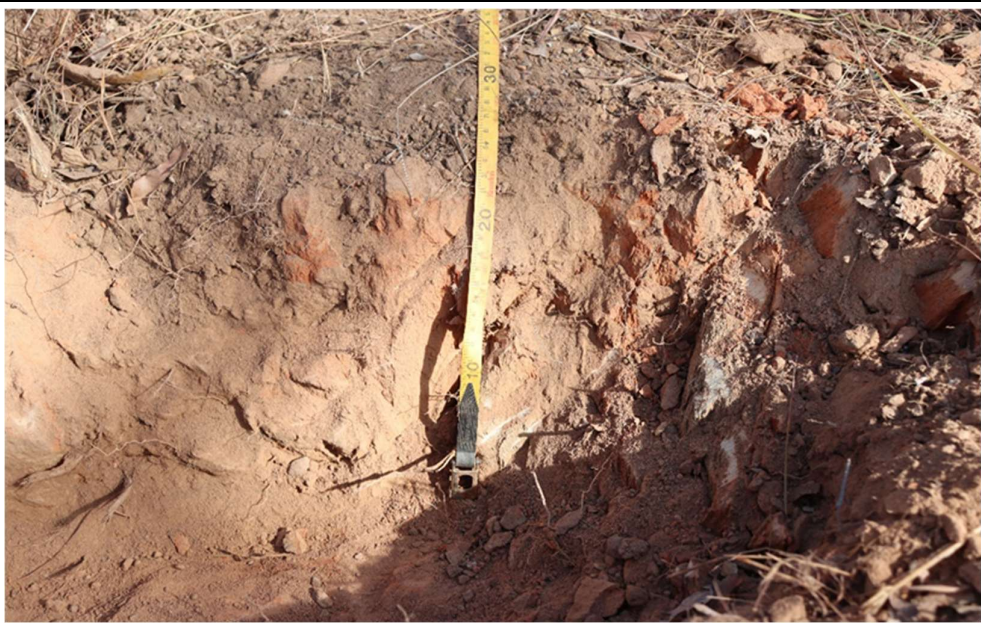
| Waste dump 01<br>site setting | soil pit |

Notes. very thin soil profile. O+A+B1 only a few cm thick maximum. Doesn't appear to be a properly defined B2 horizon, rather straight into B3-C Horizon of weathered meta sedimentary saprock.  
Photos 4271 - 4275

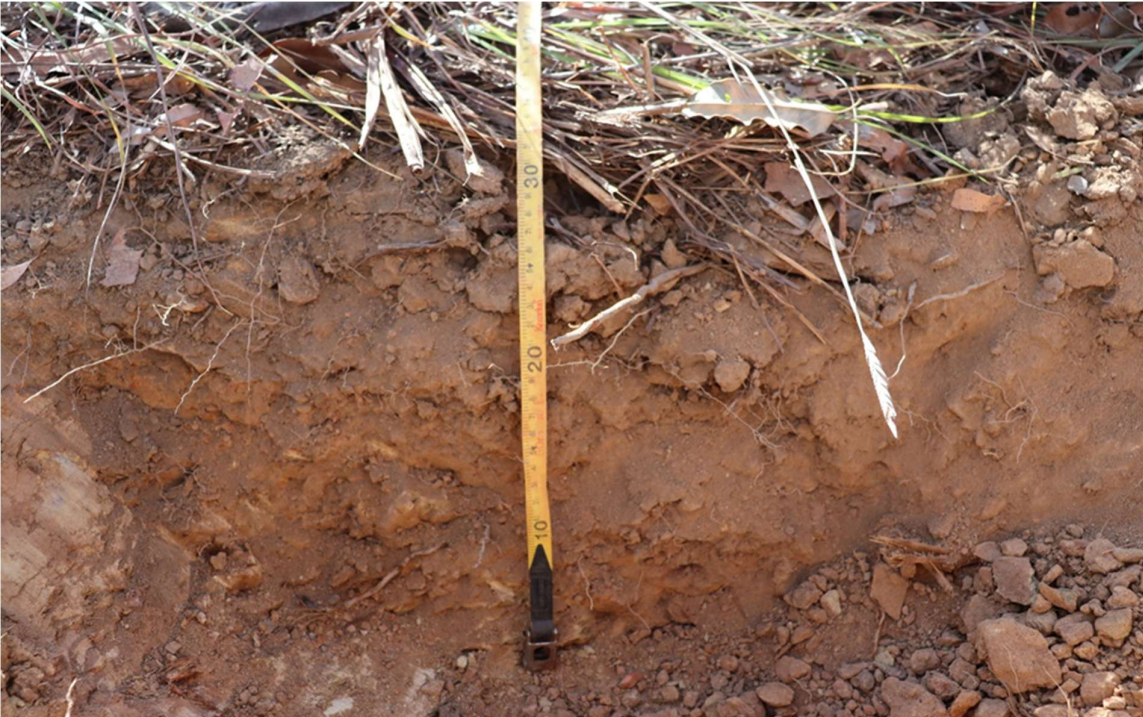
| Waste<br>dump<br>01 site<br>setting | soil pit |

Notes. Very thin soil profile, no well defined horizons. Photos 4276 - 4278

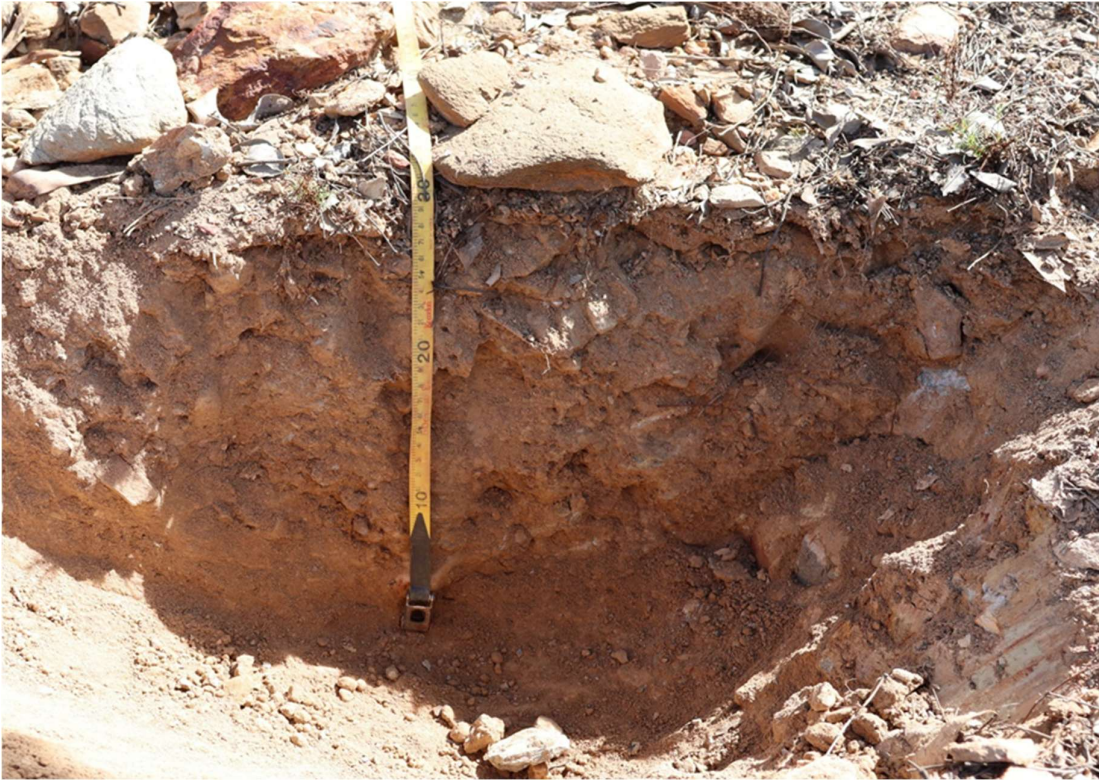
| ROM01 | soil pit |

Notes :Entirely in waste pile, no O, A or B horizons. Photos 4289 - 4292

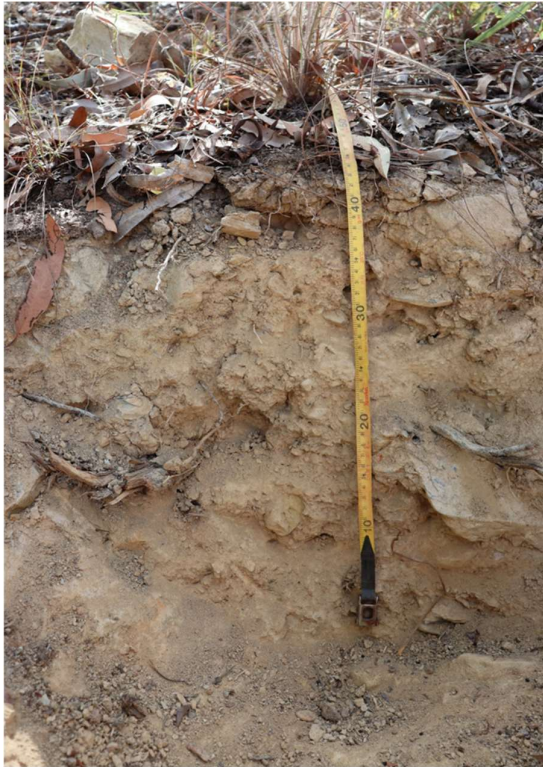
| ROM02 | soil pit |

Notes :Entirely V thin <= 5cm of brown organic material + A horizon overlying old waste pile from mine. Photos 4282 - 4285

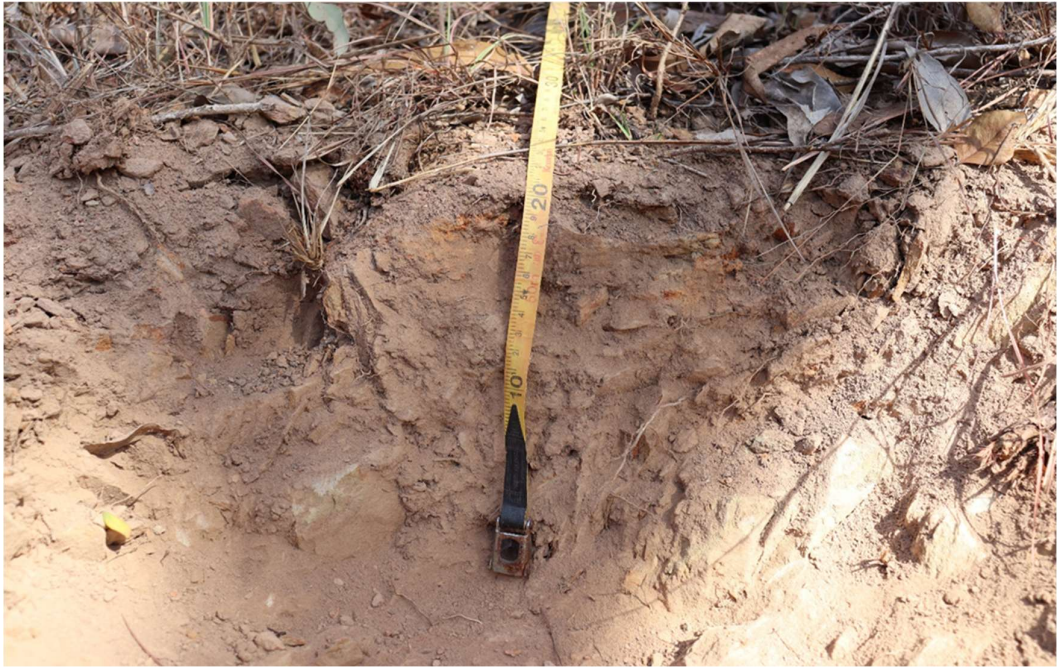
| ROM03 | soil pit |

Notes : Very thin soil profile. O + A + B in one sample. Horizons not well defined and very thin.  
Photos 4279 - 4281

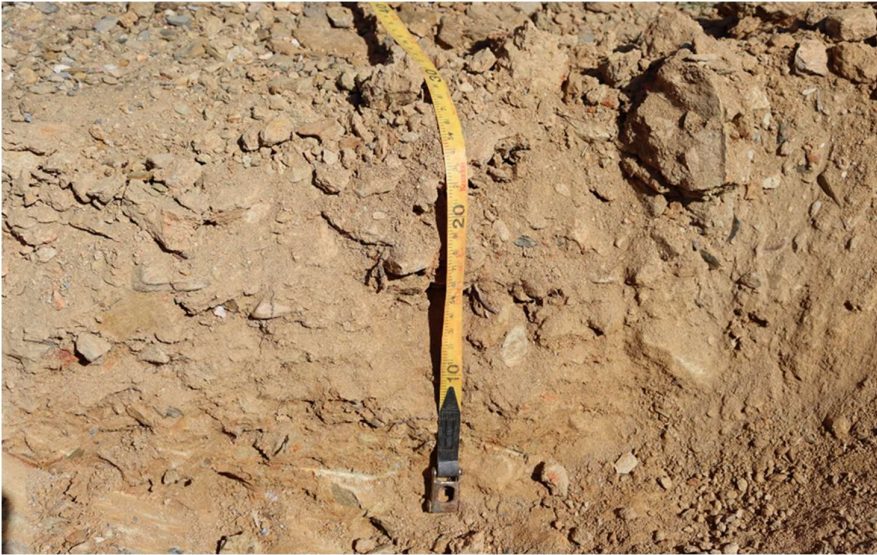
| ROM04 | soil pit |

Notes : Entirely in waste pile. Zero organic material/ veg, no A or B horizon. Photos 4286 - 4288
