Dianne Copper Mine

Dianne Recommencement Project

Consequence Category Assessment

R2247-PRO-CI-RP-010

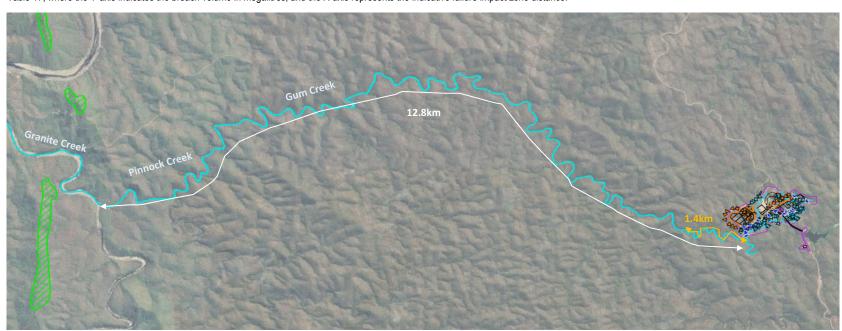
Dam breach volume	
	KM	ML
	0	0
	3.0	300
	20	2000

To determine the extent of the dam breach, this CCA report references Table 17 from the Guidelines for Failure Impact Assessment of Water Dams, which provides an indicative total impact distance. The following graph represents Table 17, where the Y-axis indicates the breach volume in megalitres, and the X-axis represents the indicative failure impact zone distance.

In the unlikely event of a cascade failure involving the release dam and all upstream dams, the breach extent would reach 1.4 km. However, the environmental impact would not meet the criteria for classification as "High" or "Significant."

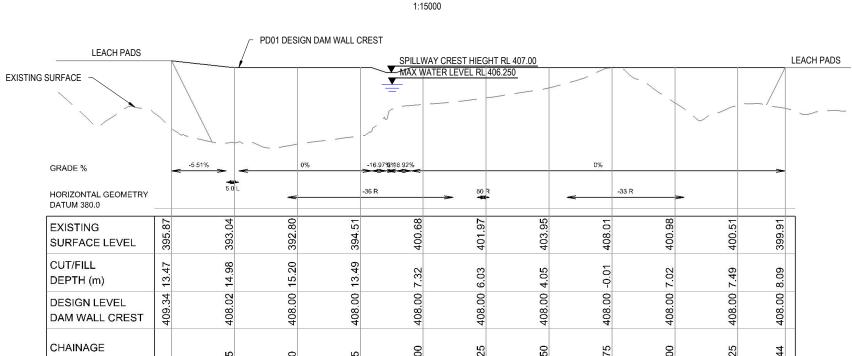
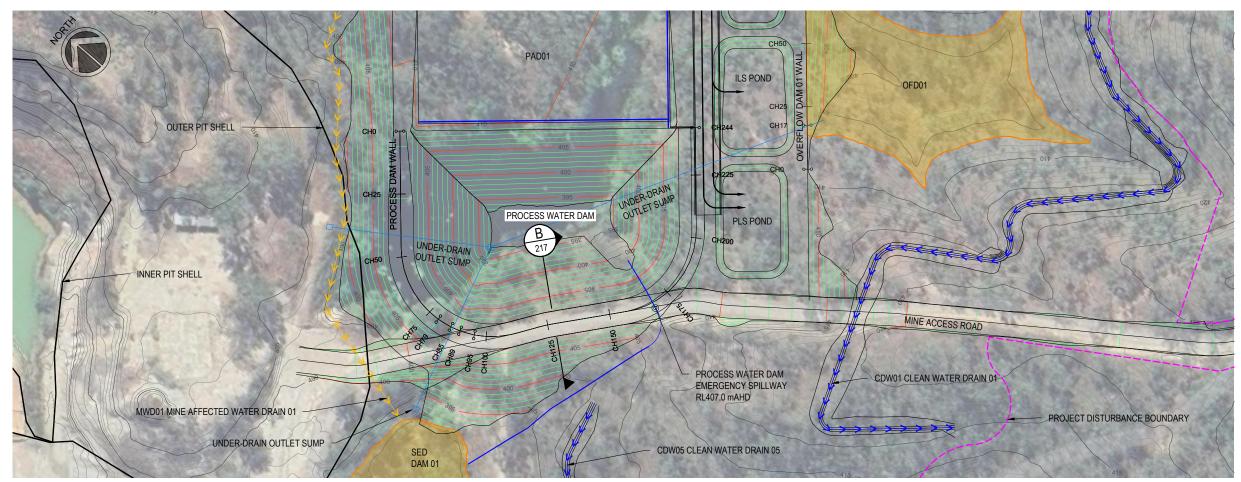
DRAWING TITLE:	PD01 PROCESS WA	TER DAM - PLAN 8	& LONGSECTION

LONGITUDINAL SECTION - PD01 PROCESS WATER DAM WALL
Horizontal scale 1:7500
Vertical scale 1:750

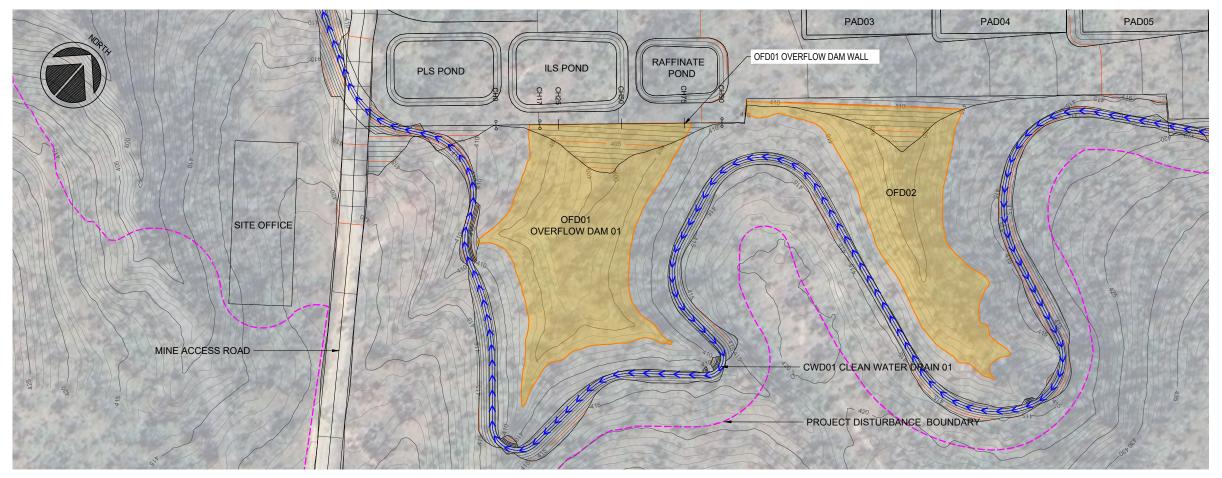
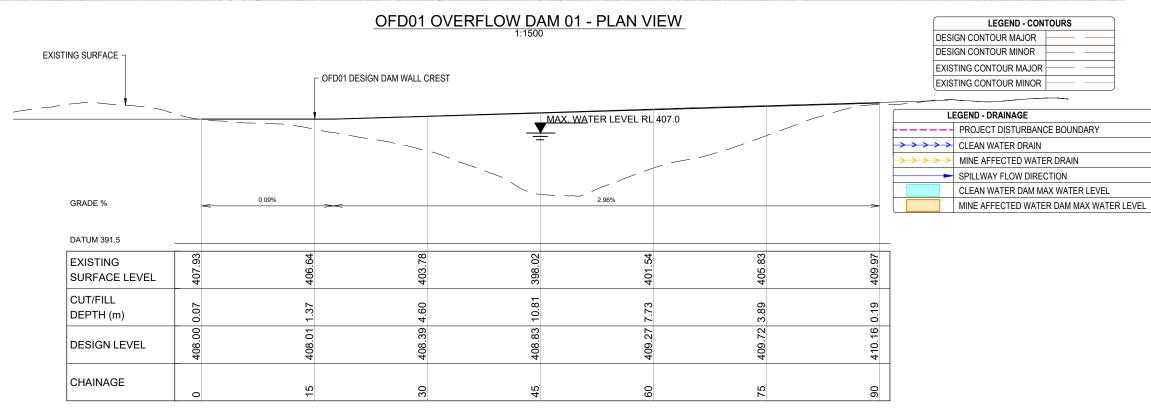
DRAWING TITLE: OVERFLOW DAM	01 - PLAN & LOI	NGSECTION

LONGITUDINAL SECTION - OFD01 OVERFLOW DAM WALL
Horizontal scale 1:500
Vertical scale 1:500

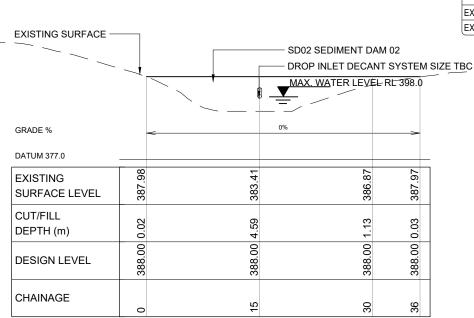
DRAWING TITLE: SEDIMENT DAM 02 - PLAN AND LONGITUDINAL SECTION							
SCALE: AS SHOWN	SHEET SIZE: A3	DRAWING NO. : J022.200.52-DWG-001	REVISION NO.: B	SHEET NO. 21

LONGITUDINAL SECTION - SD02 SEDIMENT DAM WALL
Horizontal scale 1:500
Vertical scale 1:500

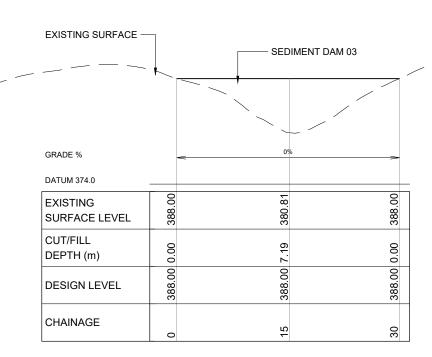
LONGITUDINAL SECTION - SD03 SEDIMENT DAM WALL
Horizontal scale 1:500
Vertical scale 1:500

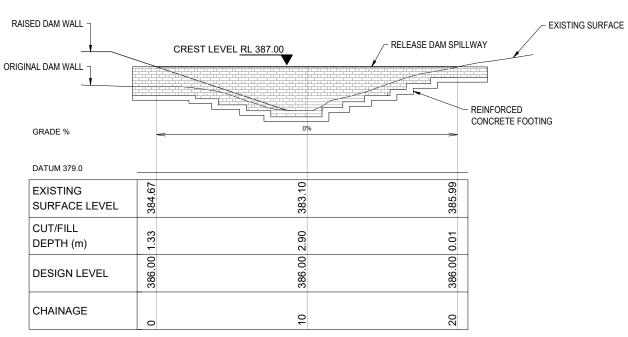
DRAWING TITLE: RELEASE DAM SPILLWAY - PLAN & SECTION								
SCALE: AS SHOWN	0	DRAWING NO.: J022.200.40-DWG-003 CCE DRAWING REF NO.: R2247-PRO-CI-DW-408a	SHEET No.: 408a	REV.: A				
Note: Ensure the scale used aligns with drawing requirements

LONGITUDINAL SECTION - RD01 RELEASE DAM WEIR Horizontal scale 1:250 Vertical scale 1:250
