# **DIANNE COPPER MINE**

## **Progressive Rehabilitation and Closure Plan**

**October 2025**

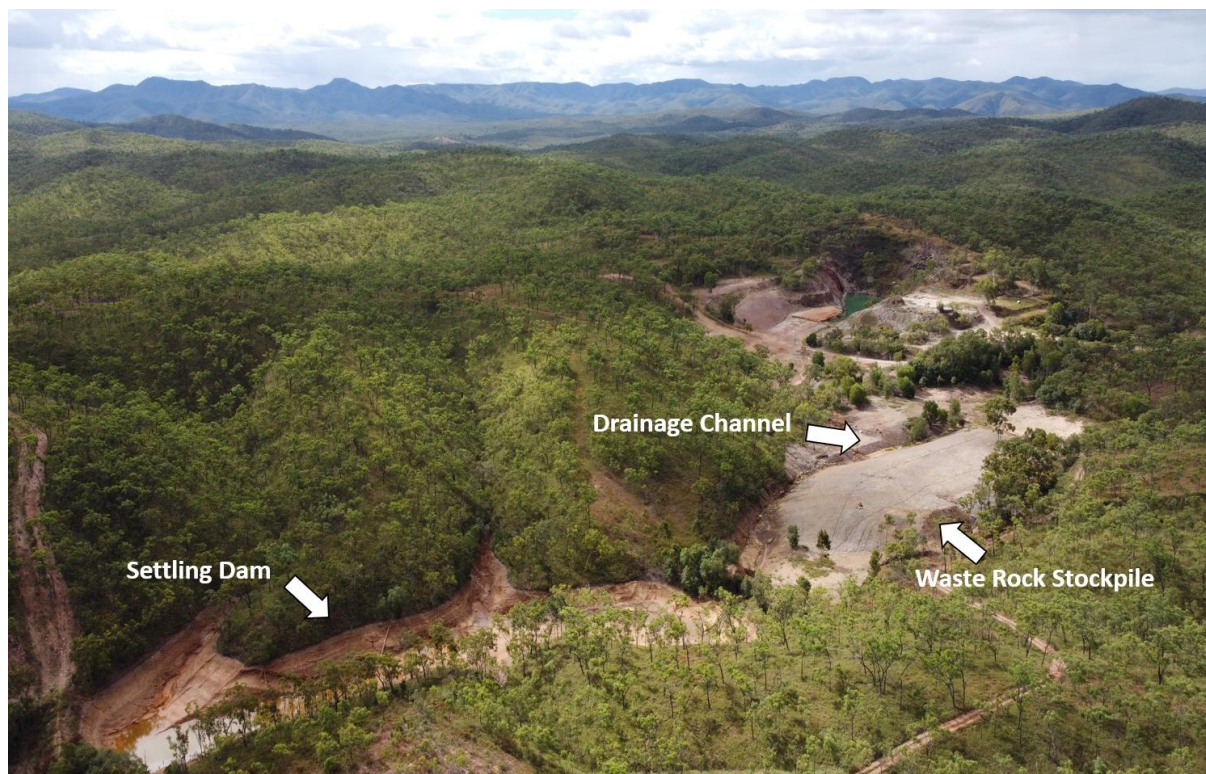
**Figure 11: Waste Rock Stockpile (May 2021)**

There is one existing waste rock stockpile on site, totalling 0.98 ha. The existing waste rock stockpile will be reprocessed as part of the project. The existing waste rock stockpile has been reprofiled and compacted to prevent ponding and reduce water infiltration, including the installation of contour drains to ensure run off flows into the Settling Dam. A drainage channel has been installed north of the waste rock stockpile to divert water around the area and directly into the Settling Dam. An additional bund has been installed upstream of the waste rock stockpile, to divert all overland flow (clean water) around disturbance areas.
