# **DIANNE COPPER MINE**

## **Progressive Rehabilitation and Closure Plan**

**February 2025**

**EA holder:** Mineral Projects Pty Ltd and Tableland Resources Pty Ltd  
**EA Holder Contact Details:** Mineral Projects Pty Ltd located at Level 15, 300  
Queen Street, Brisbane, QLD, 4000  
**Tenure:** ML 2810, ML 2811, ML 2831, ML 2832, ML 2833 and ML 2834  
**Document ID:** DCM\_PRCP\_2024\_v2  
**Version:** 2.0  
**Date of Submission:** February 2025

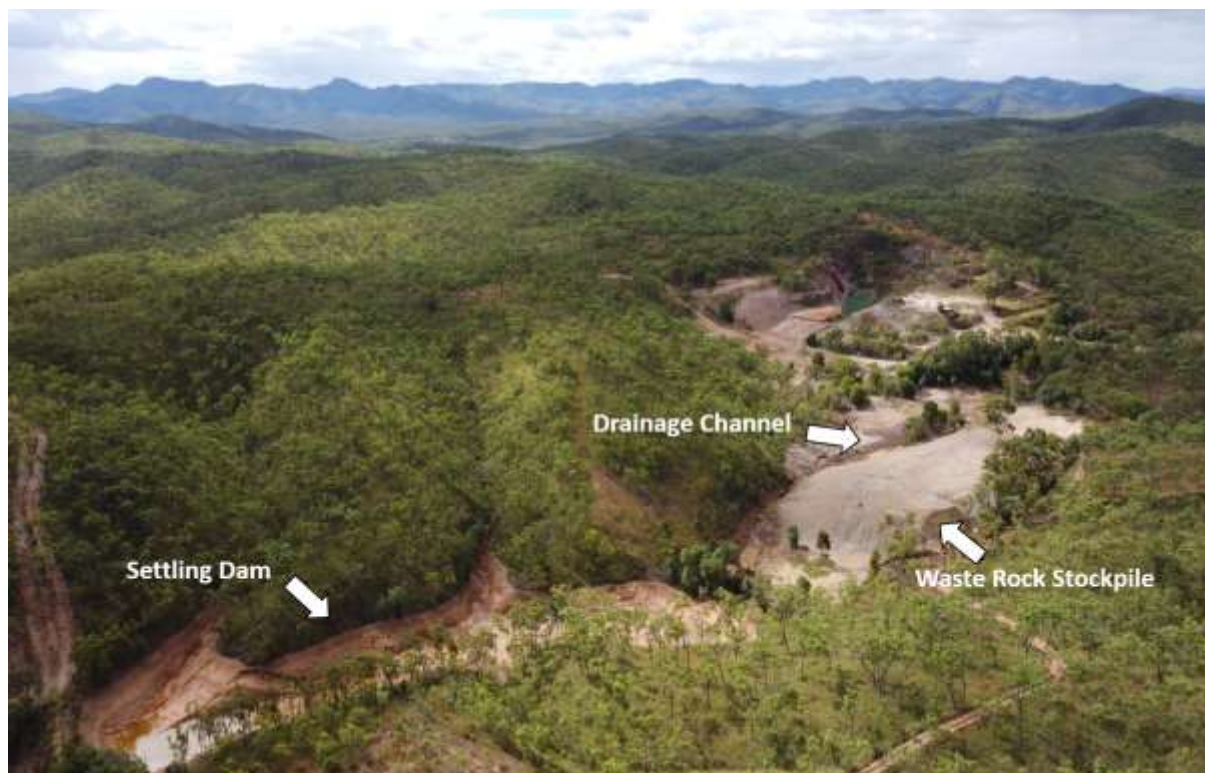
**Figure 8: Waste Rock Stockpile (May 2021)**

There is one existing waste rock stockpile on site, totalling 0.98 ha. The existing waste rock stockpile will be reprocessed as part of the project. The existing waste rock stockpile has been reprofiled and compacted to prevent ponding and reduce water infiltration, including the installation of contour drains to ensure run off flows into the Settling Dam. A drainage channel has been installed north of the waste rock stockpile to divert water around the area and directly into the Settling Dam. An additional bund has been installed upstream of the waste rock stockpile, to divert all overland flow (clean water) around disturbance areas.
