# **Dianne Copper Mine**

# **Dianne Recommencement Project**

**Preliminary Consequence Category Assessment**

R2247-PRO-CI-RP-010

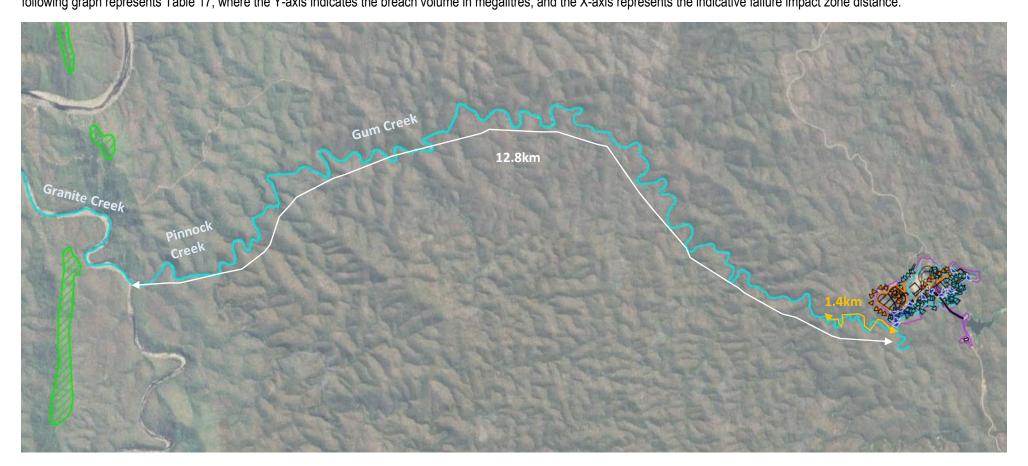
Dam breach volume
	KM	ML
	0	0
1432.5	1.4	57.3
	5	200
	20	2000
	60	20000

To determine the extent of the dam breach, this CCA report references Table 17 from the Guidelines for Failure Impact Assessment of Water Dams, which provides an indicative total impact distance. The following graph represents Table 17, where the Y-axis indicates the breach volume in megalitres, and the X-axis represents the indicative failure impact zone distance.

In the unlikely event of a cascade failure involving the release dam and all upstream dams, the breach extent would reach 1.4 km. However, the environmental impact would not meet the criteria for classification as "High" or "Significant."

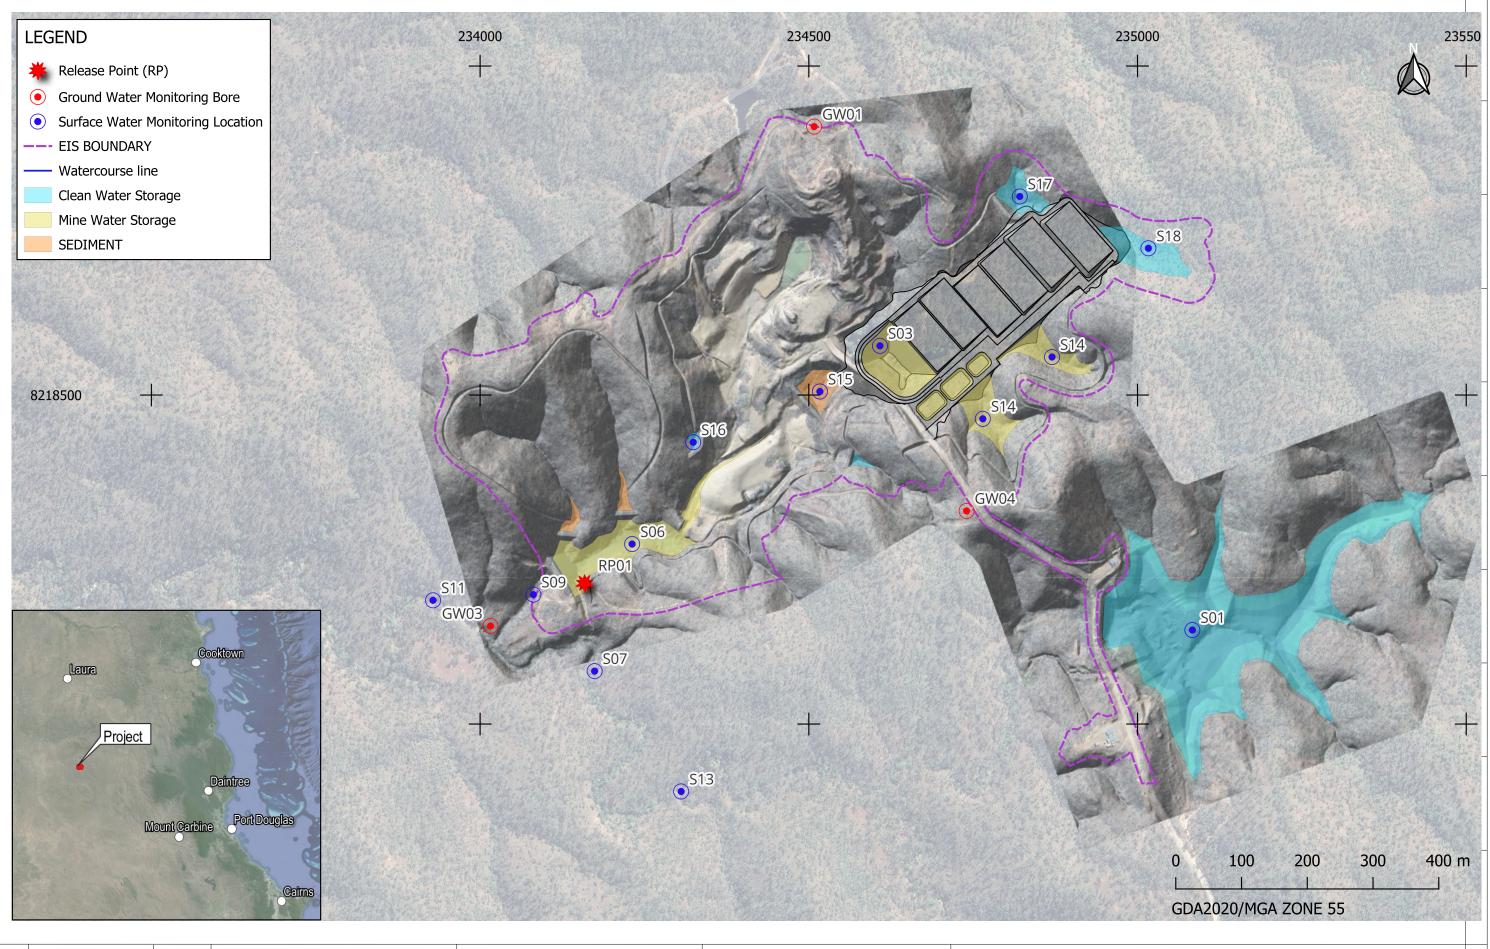
PROJECT NAME:							
DIANNE COPPER MINE							
DRAWING TITLE: STORMY	VATER MANAGEMENT - WATER MONITORING LOCATIONS						
	SHEET SIZE: A3 DRAWING NO: J022.200.00-DWG-005	: A					
NOTE: Francisch and allians with	CCE REF DRAWING NO: R2247-PRO-CI-DW-104						
NOTE: Ensure the scale used aligns with drawing requirements

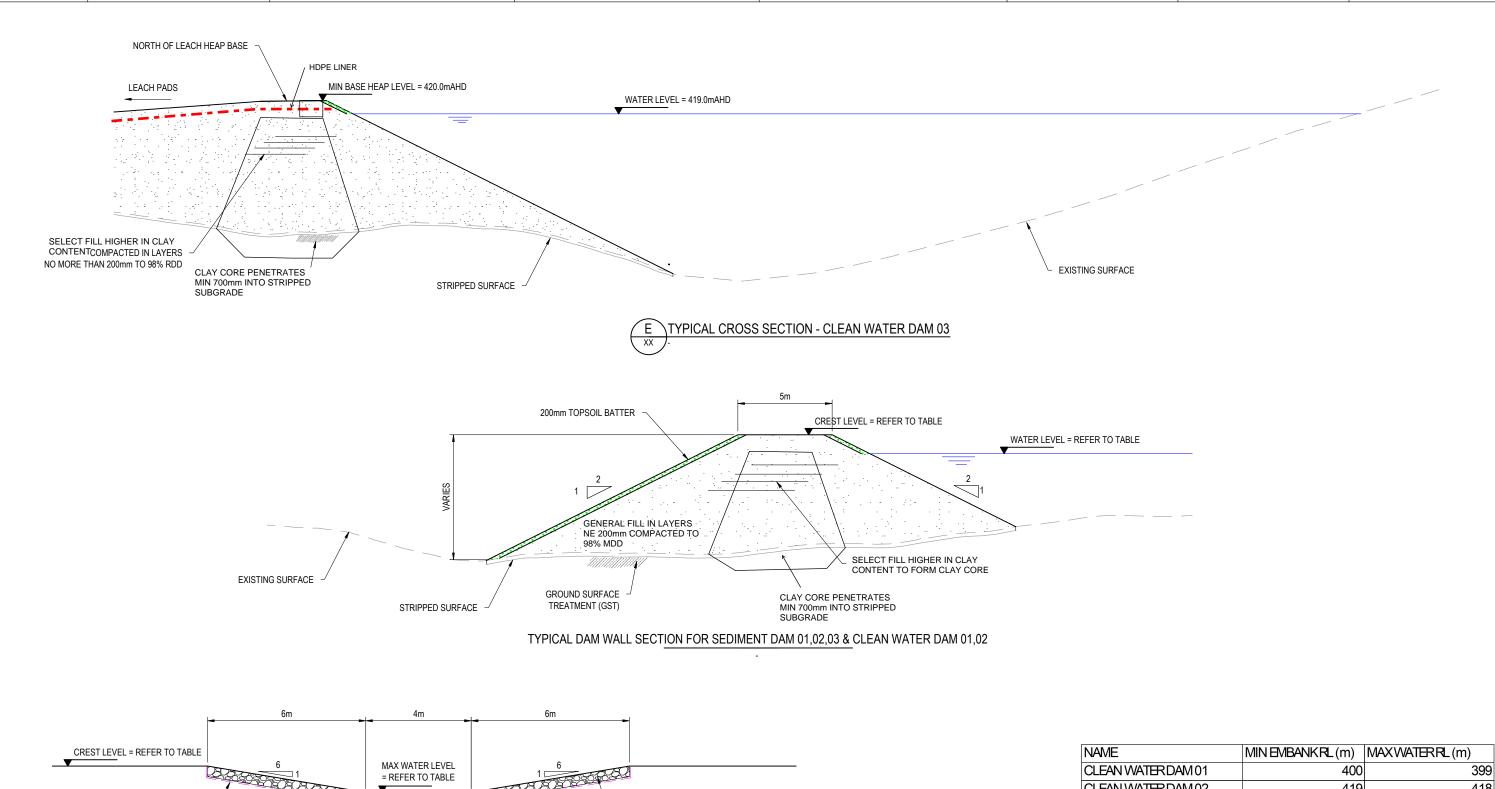
DAM EMBANKMENT & WATER LEVEL TABLE

NAME	MIN EMBANKRL(m)	MAXWATERRL(m)
CLEAN WATER DAM 01	400	399
CLEAN WATER DAM 02	419	418
CLEAN WATER DAM 03	420	419
SEDIMENT DAM 01	392	391
SEDIMENT DAM 02	388	387
SEDIMENT DAM 03	388	387
PROCESS WATER DAM	408	407
RELEASEDAM	387	386
